Debris/Ice/TPS Assessment And Photographic Analysis For Shuttle Mission STS-31R

June 1990

Charles G. Stevenson
NASA/Kennedy Space Center

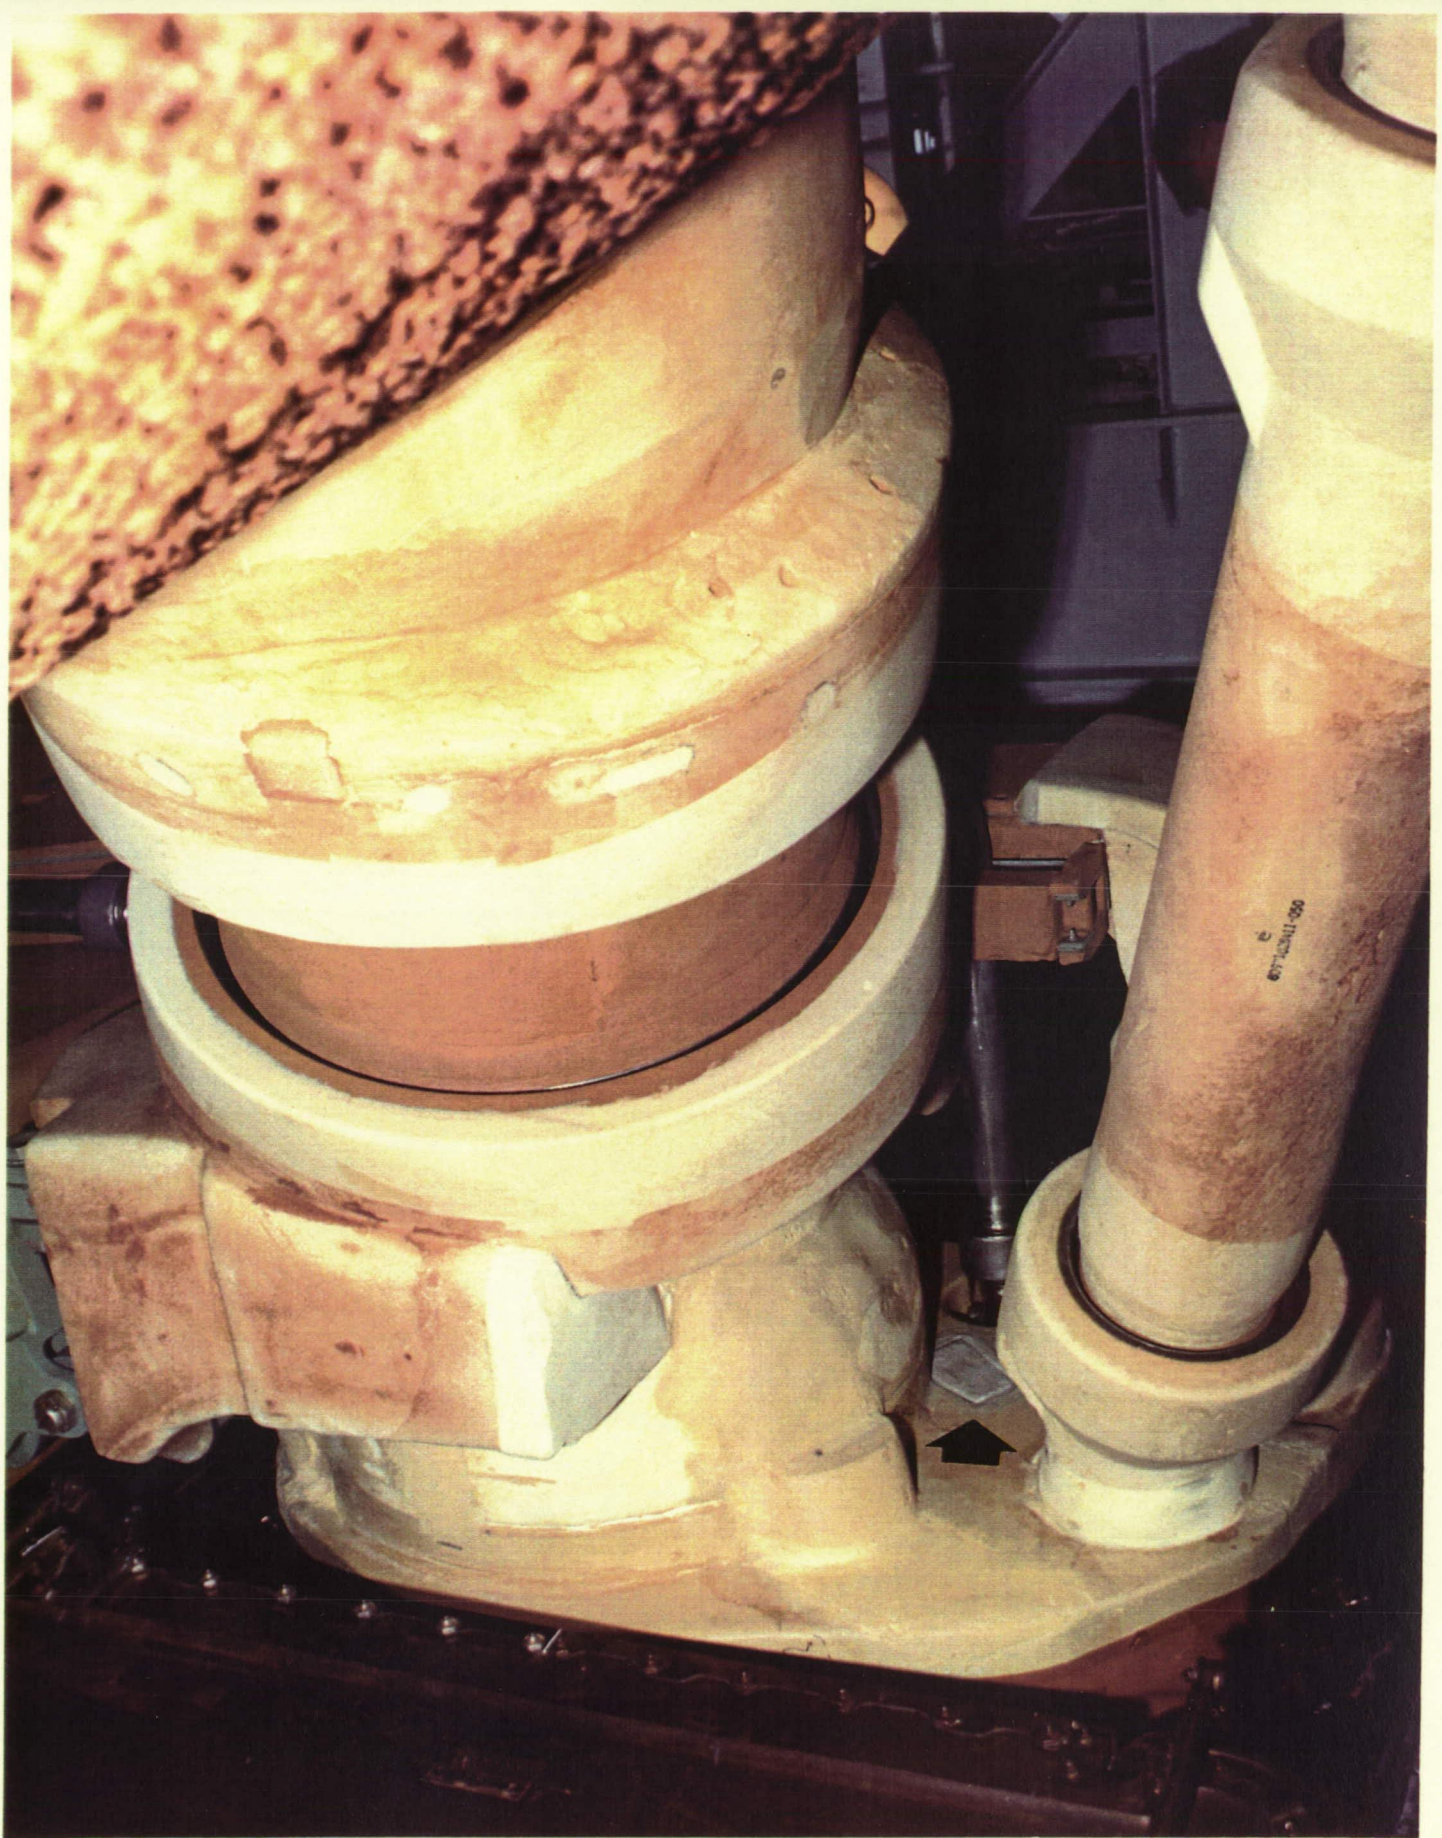
Overall view of LH2 ET/ORB umbilical. Note PDL foam plug in flapper valve actuator torque tool port closeout (arrow)

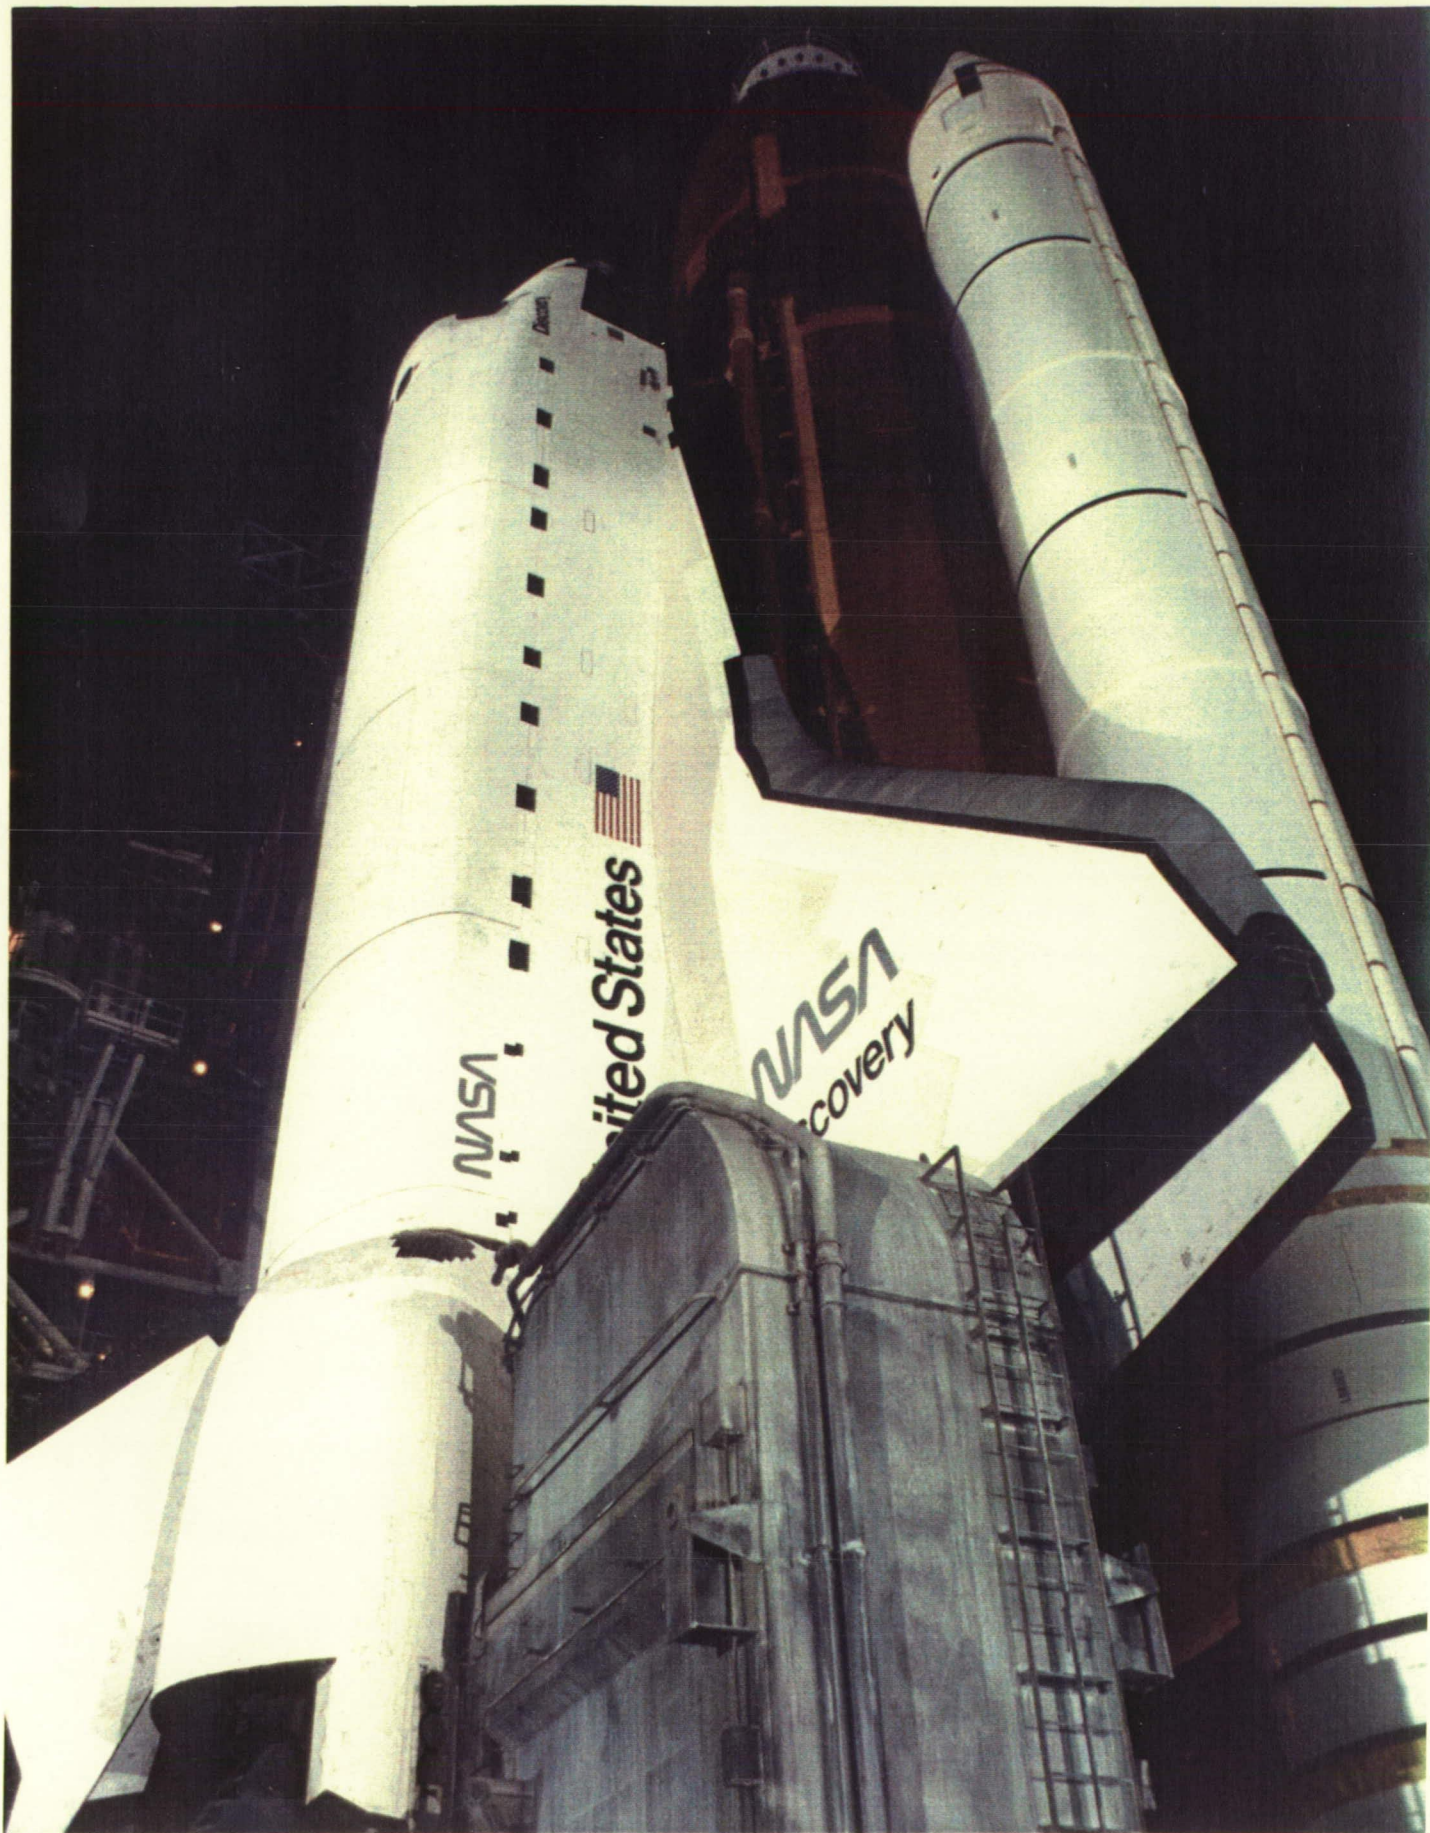
No ice/frost formed on the ET acreage +Y+Z side

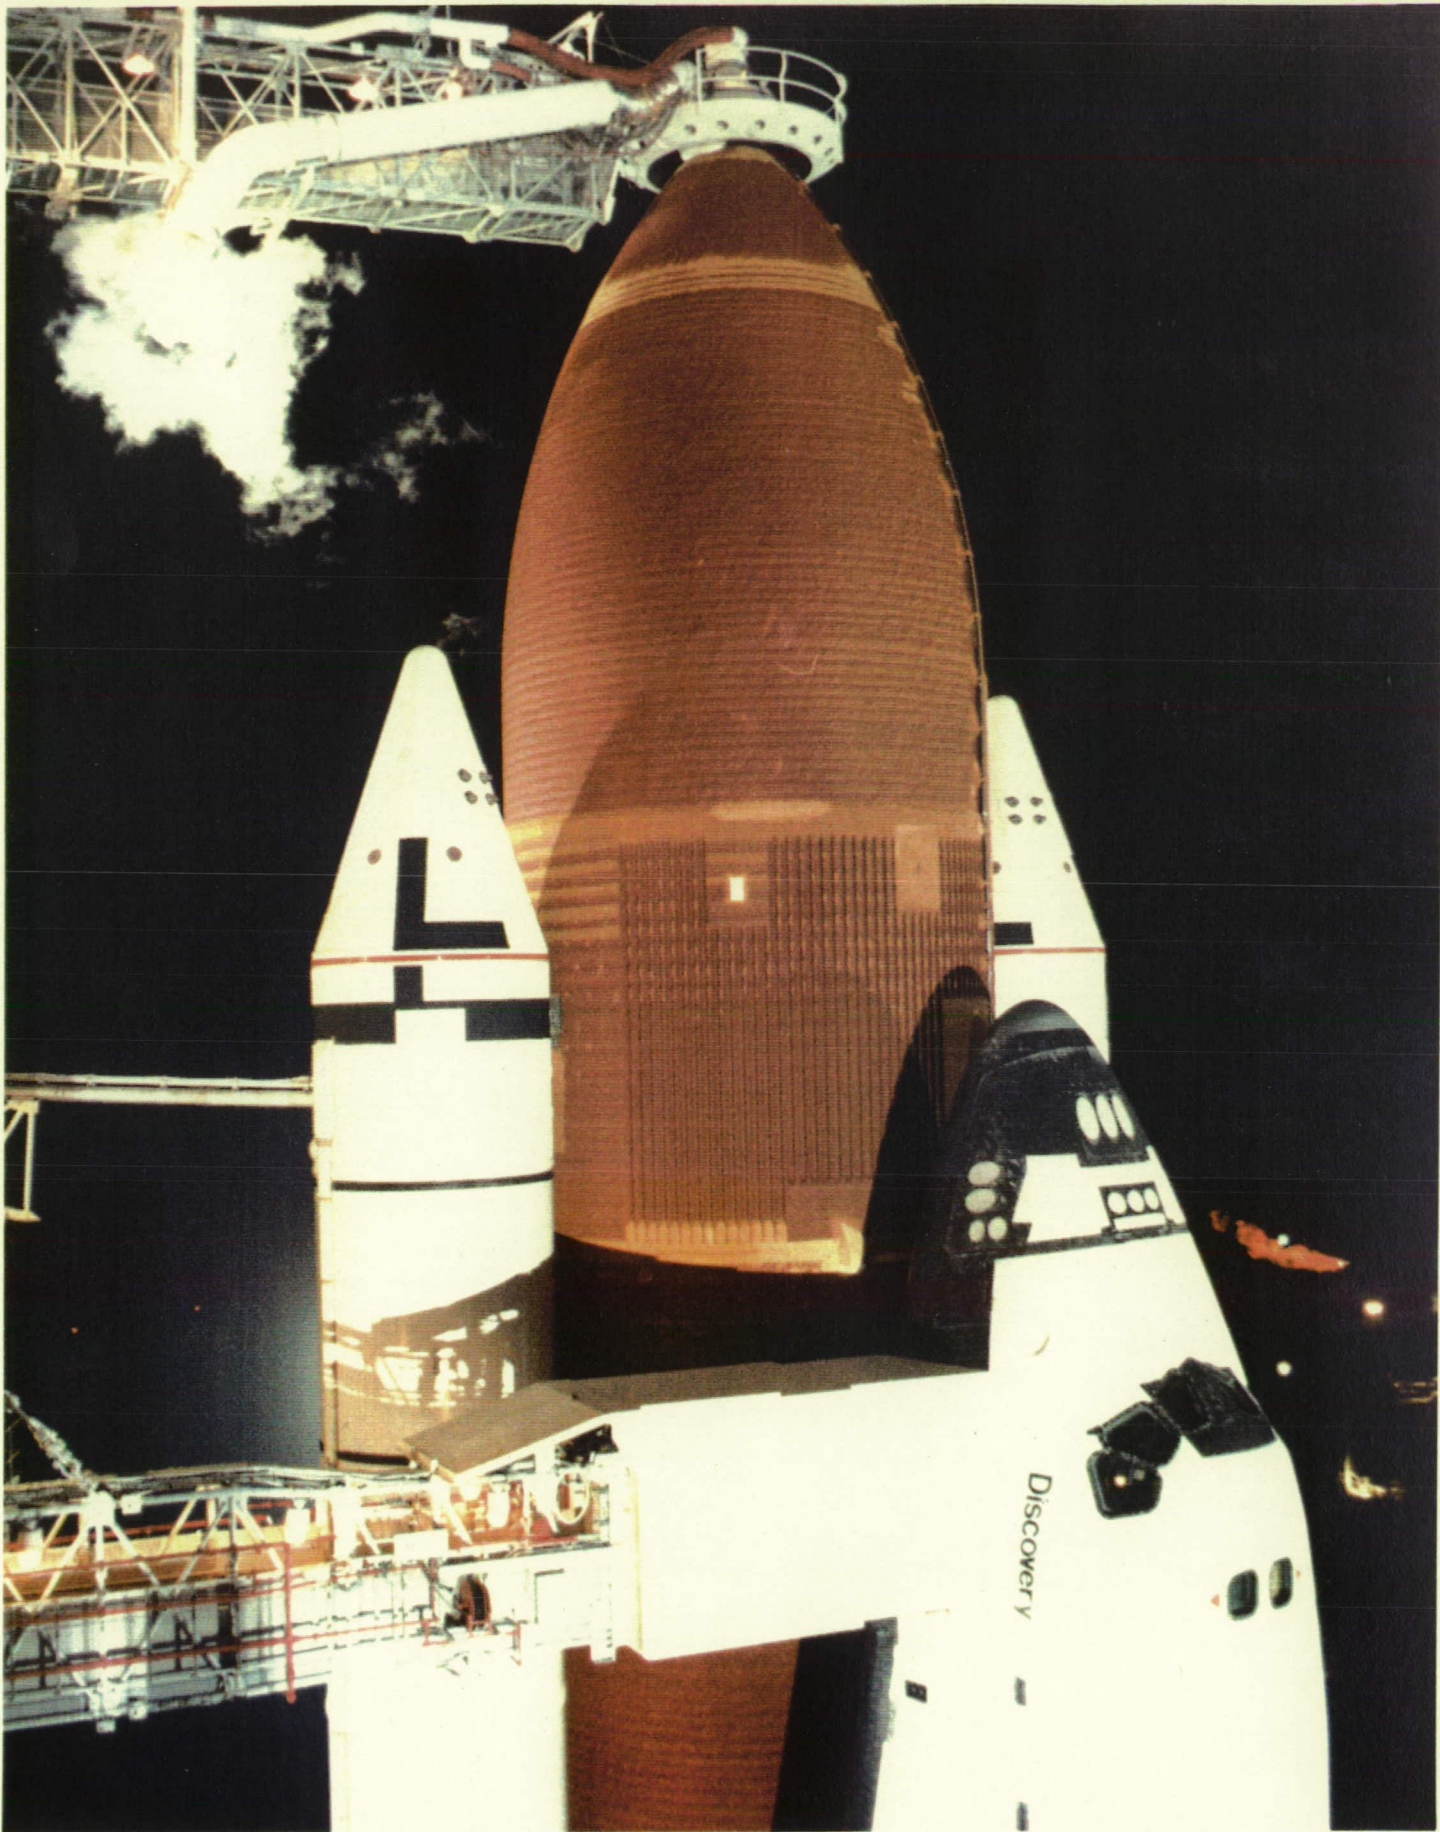
No acreage ice/frost was present on the L02 tank acreage
ogive and barrel section

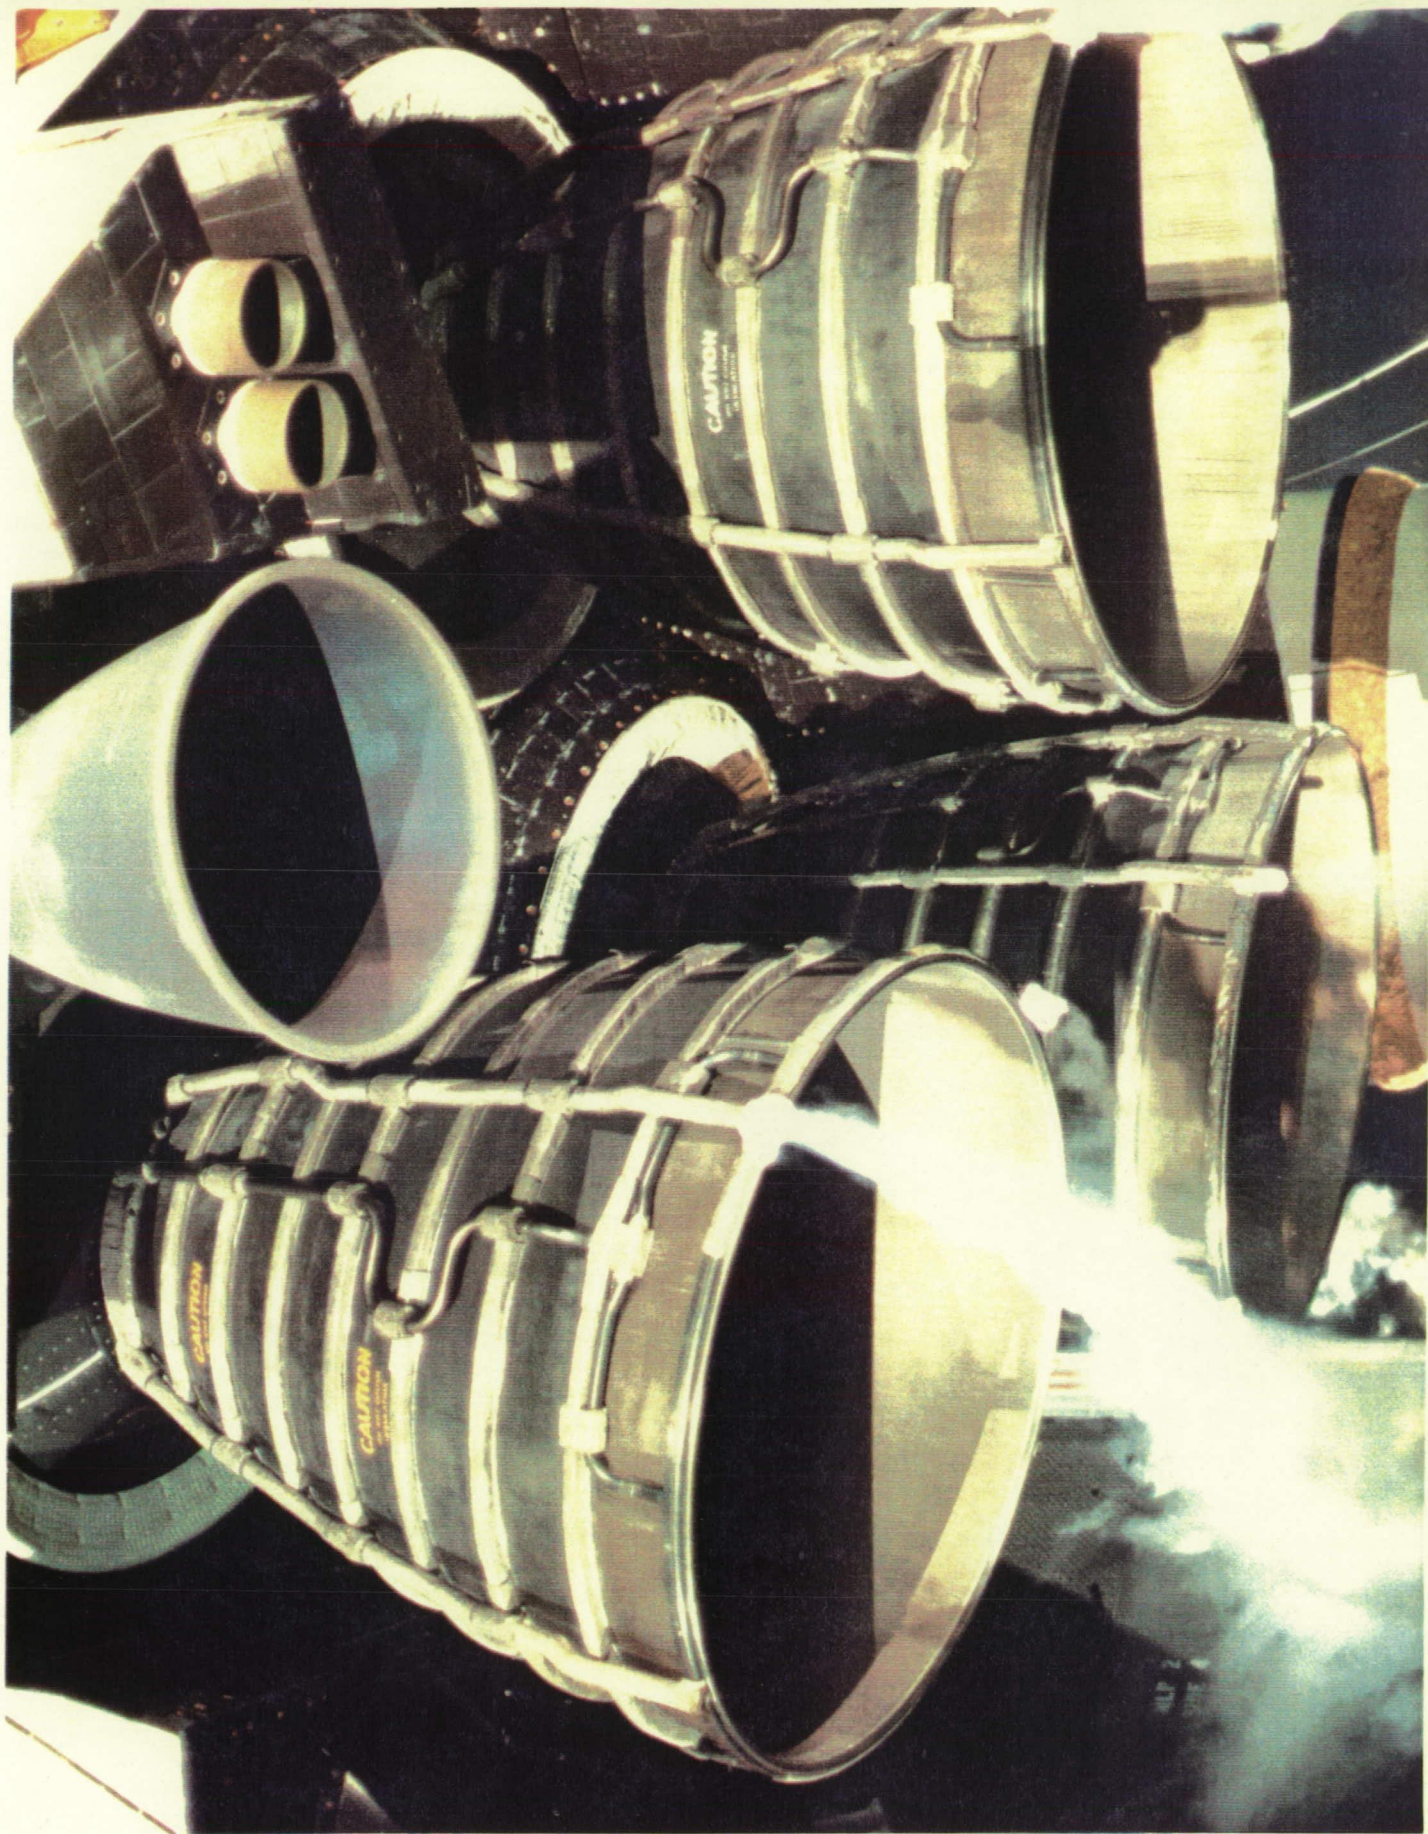
Less than usual amount of ice/frost formed at the main engine
to heat shield interfaces

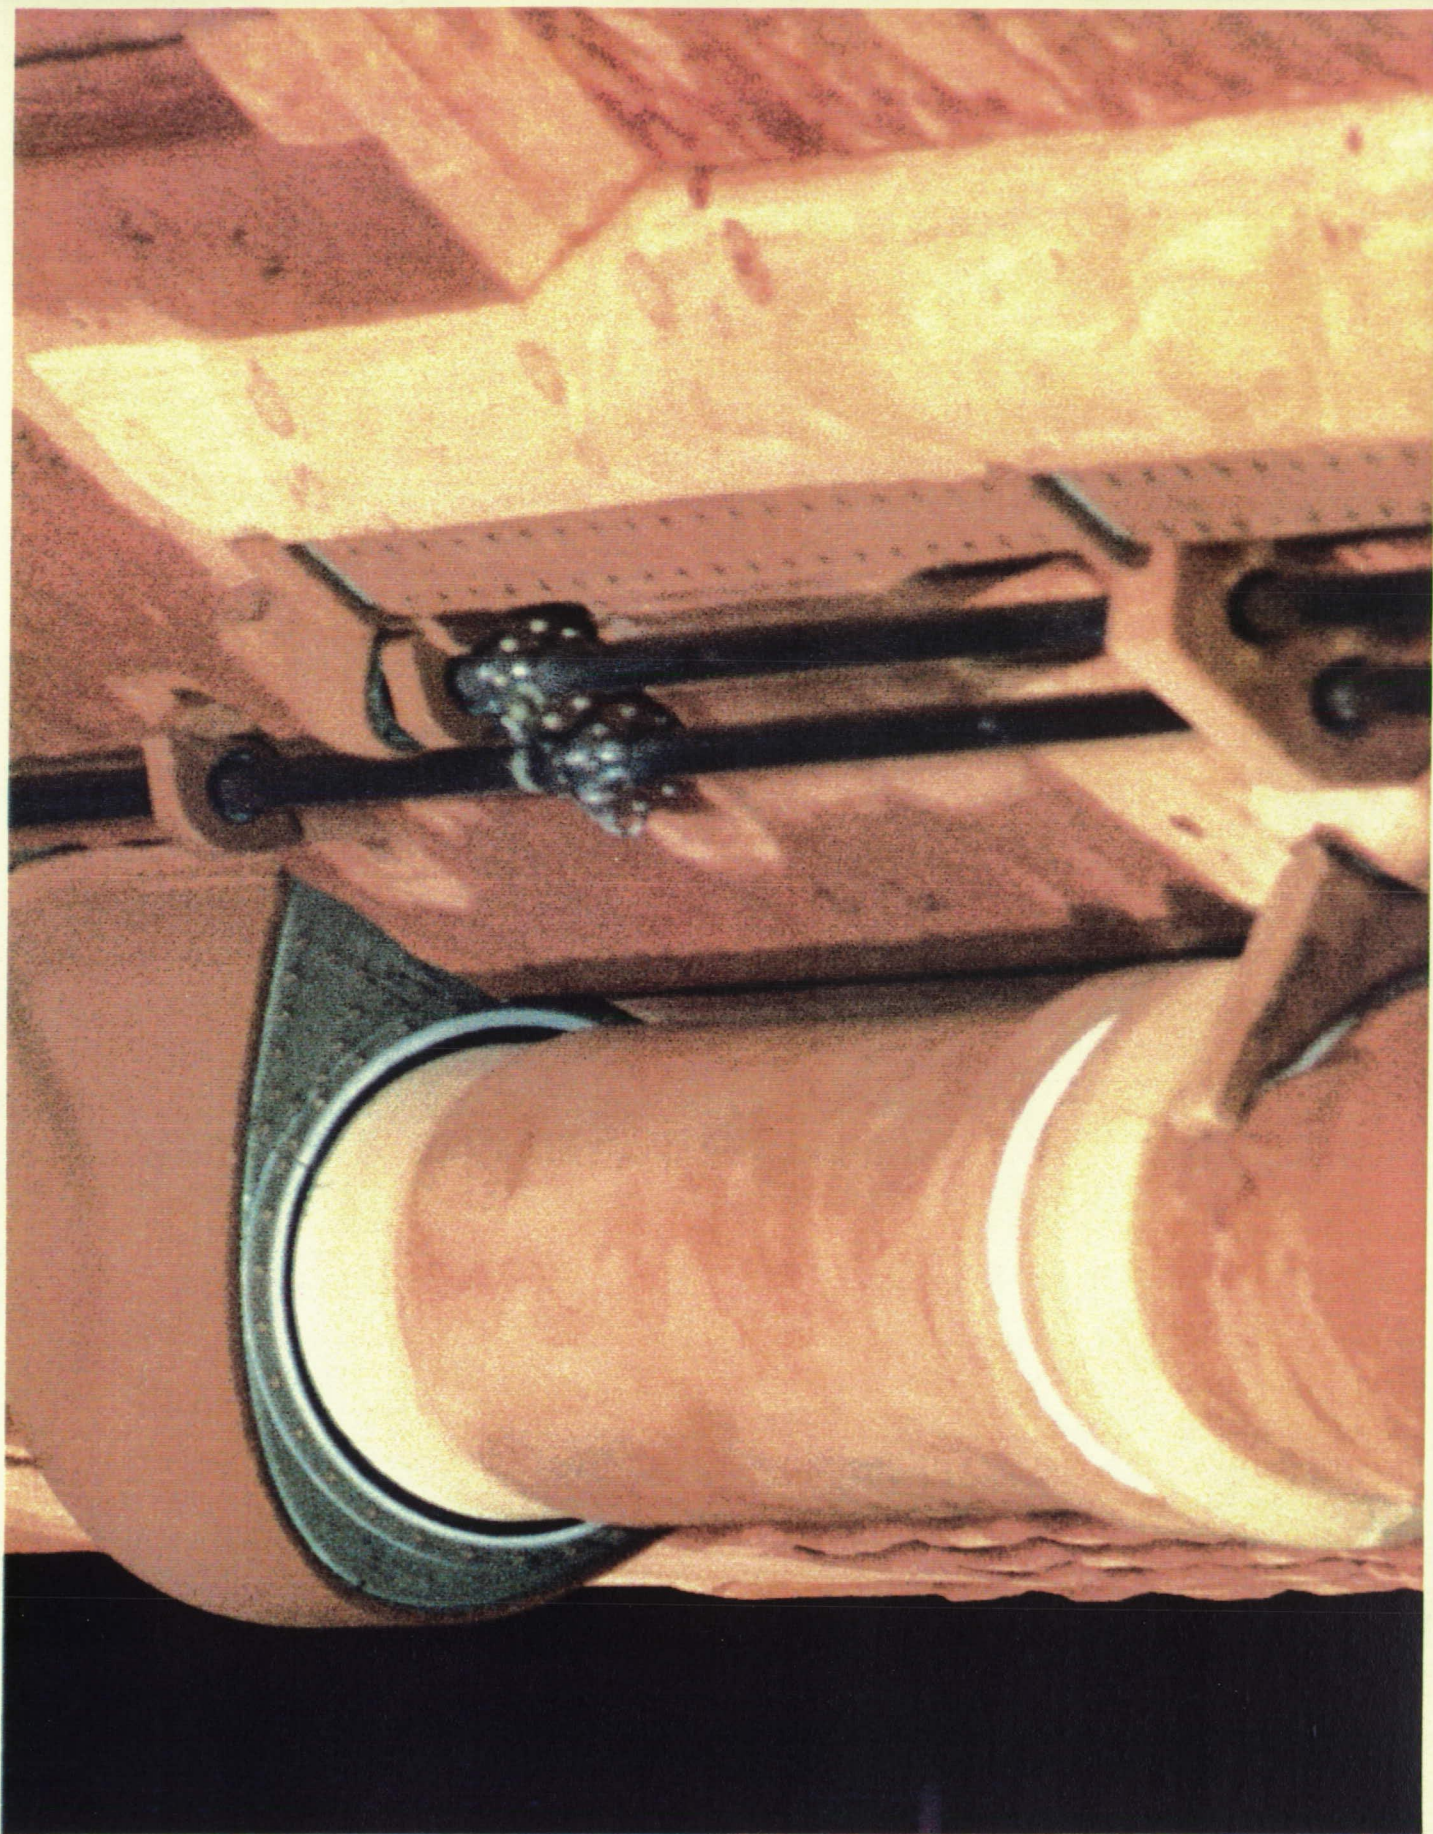
Typical amounts of ice/frost accumulated in the L02 feedline
support bracket and upper bellows

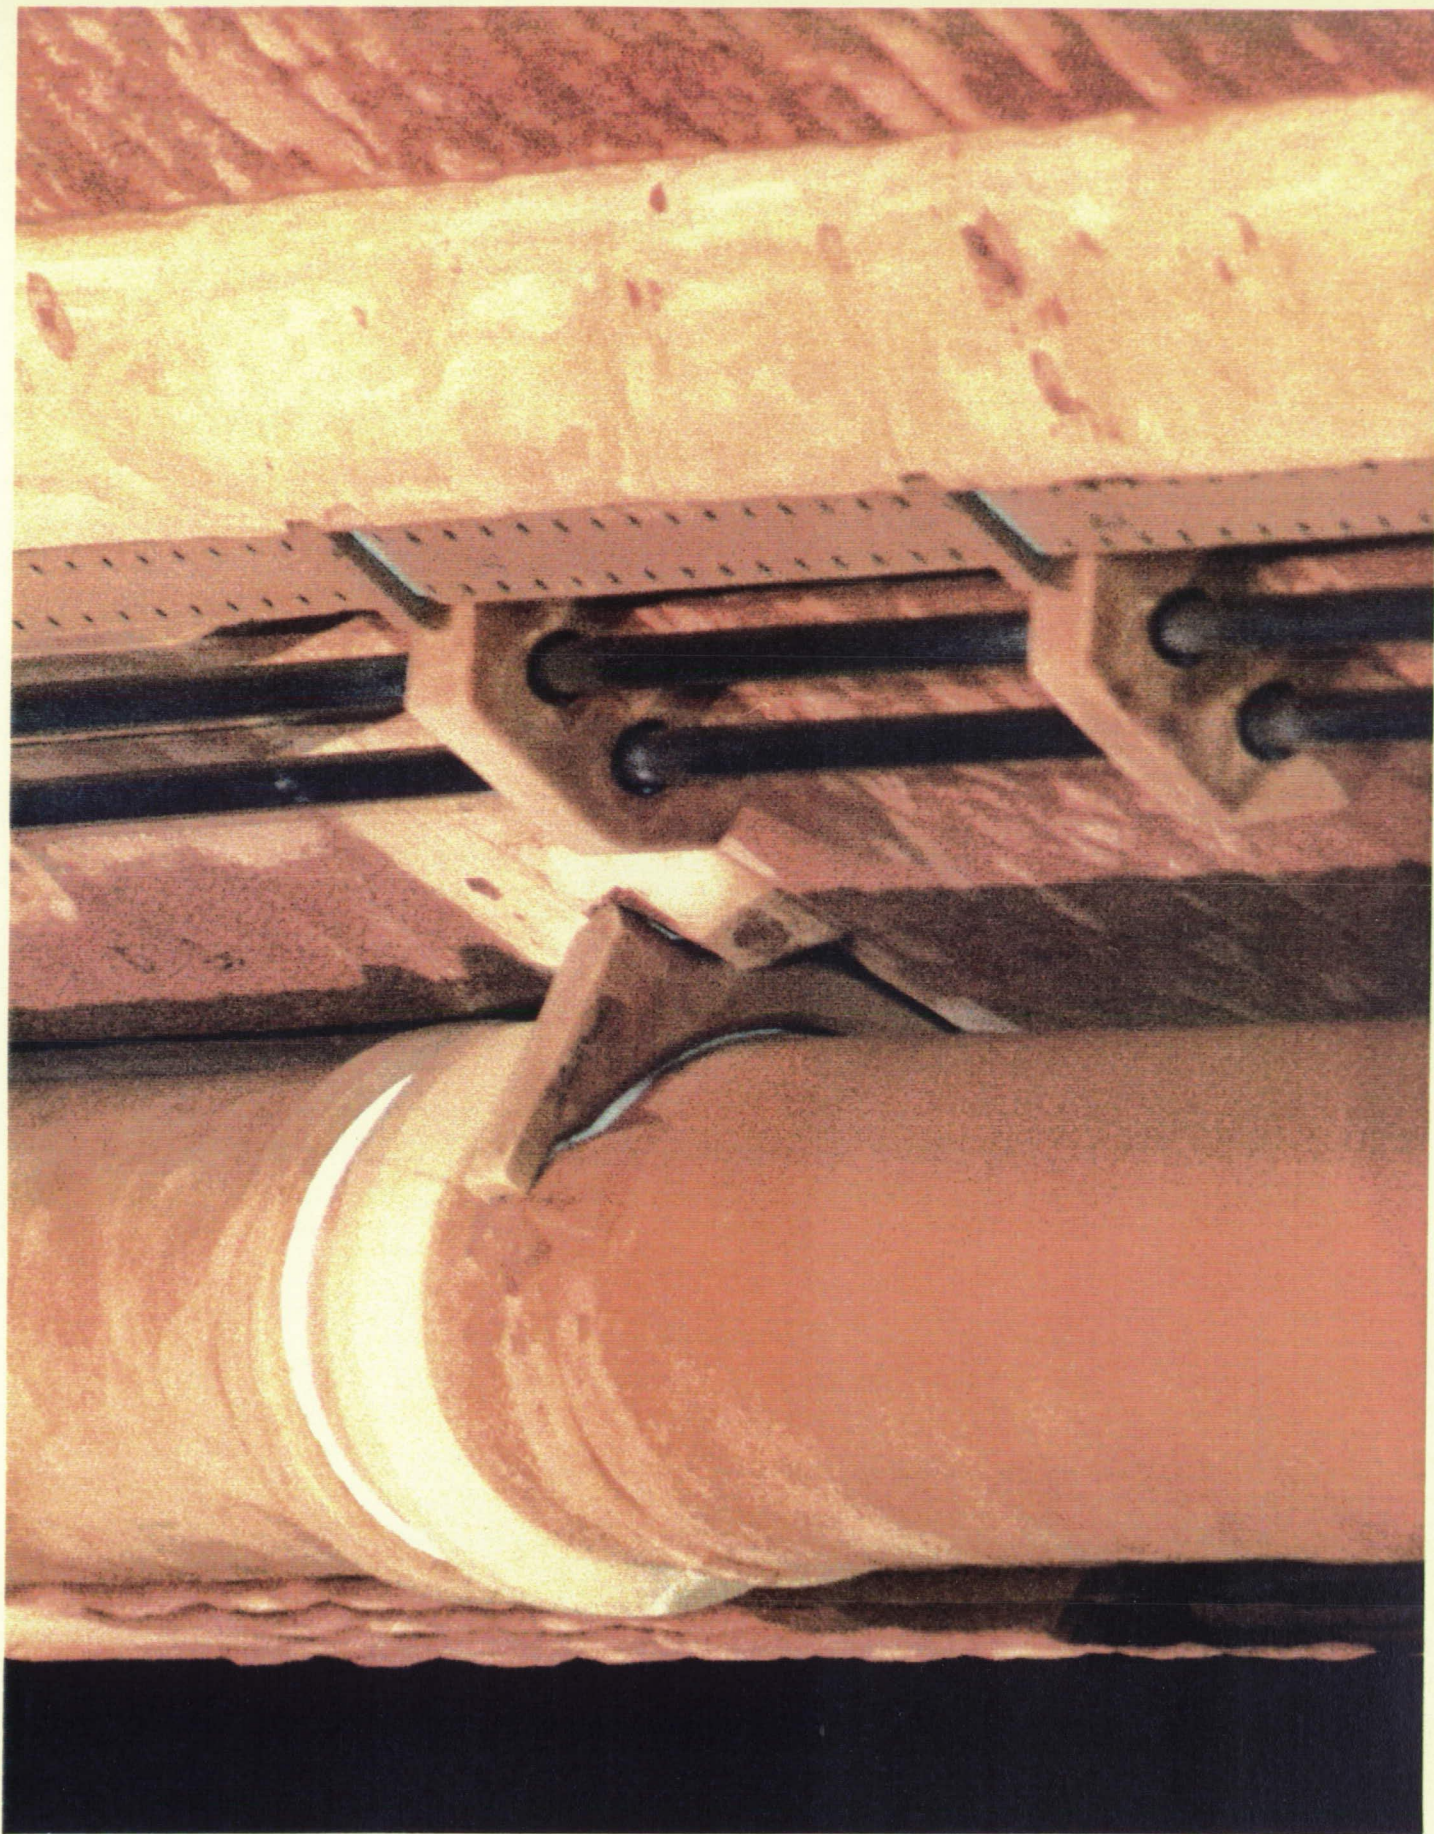
Typical amounts of ice/frost had formed in the L02 feedline
support brackets and bellows

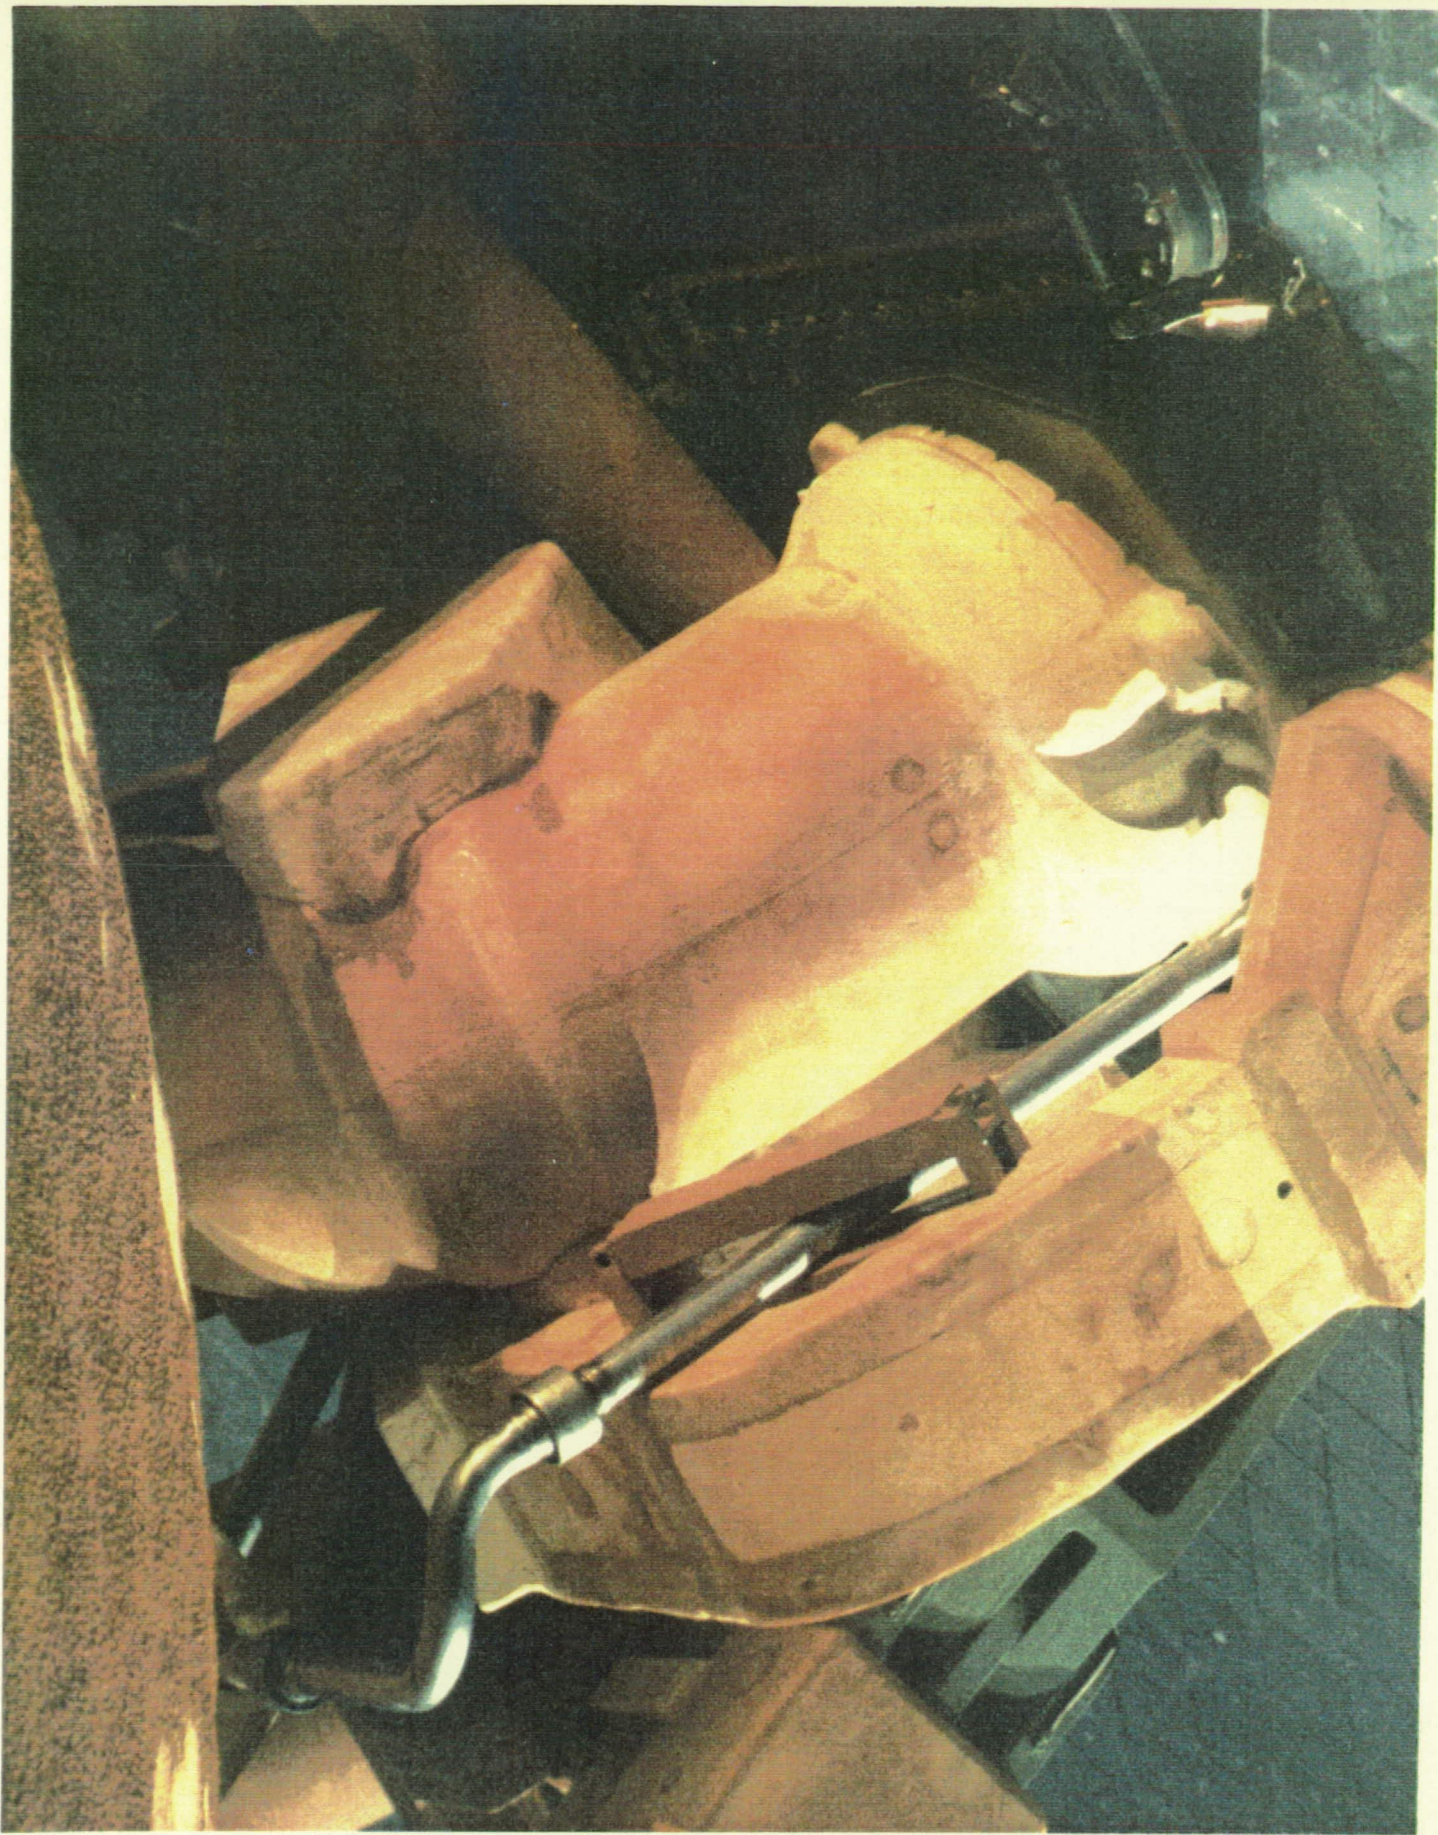
Ice/frost accumulation on the LO2 ET/ORB umbilical occurred
on the aft and inboard sides, and on the purge vents

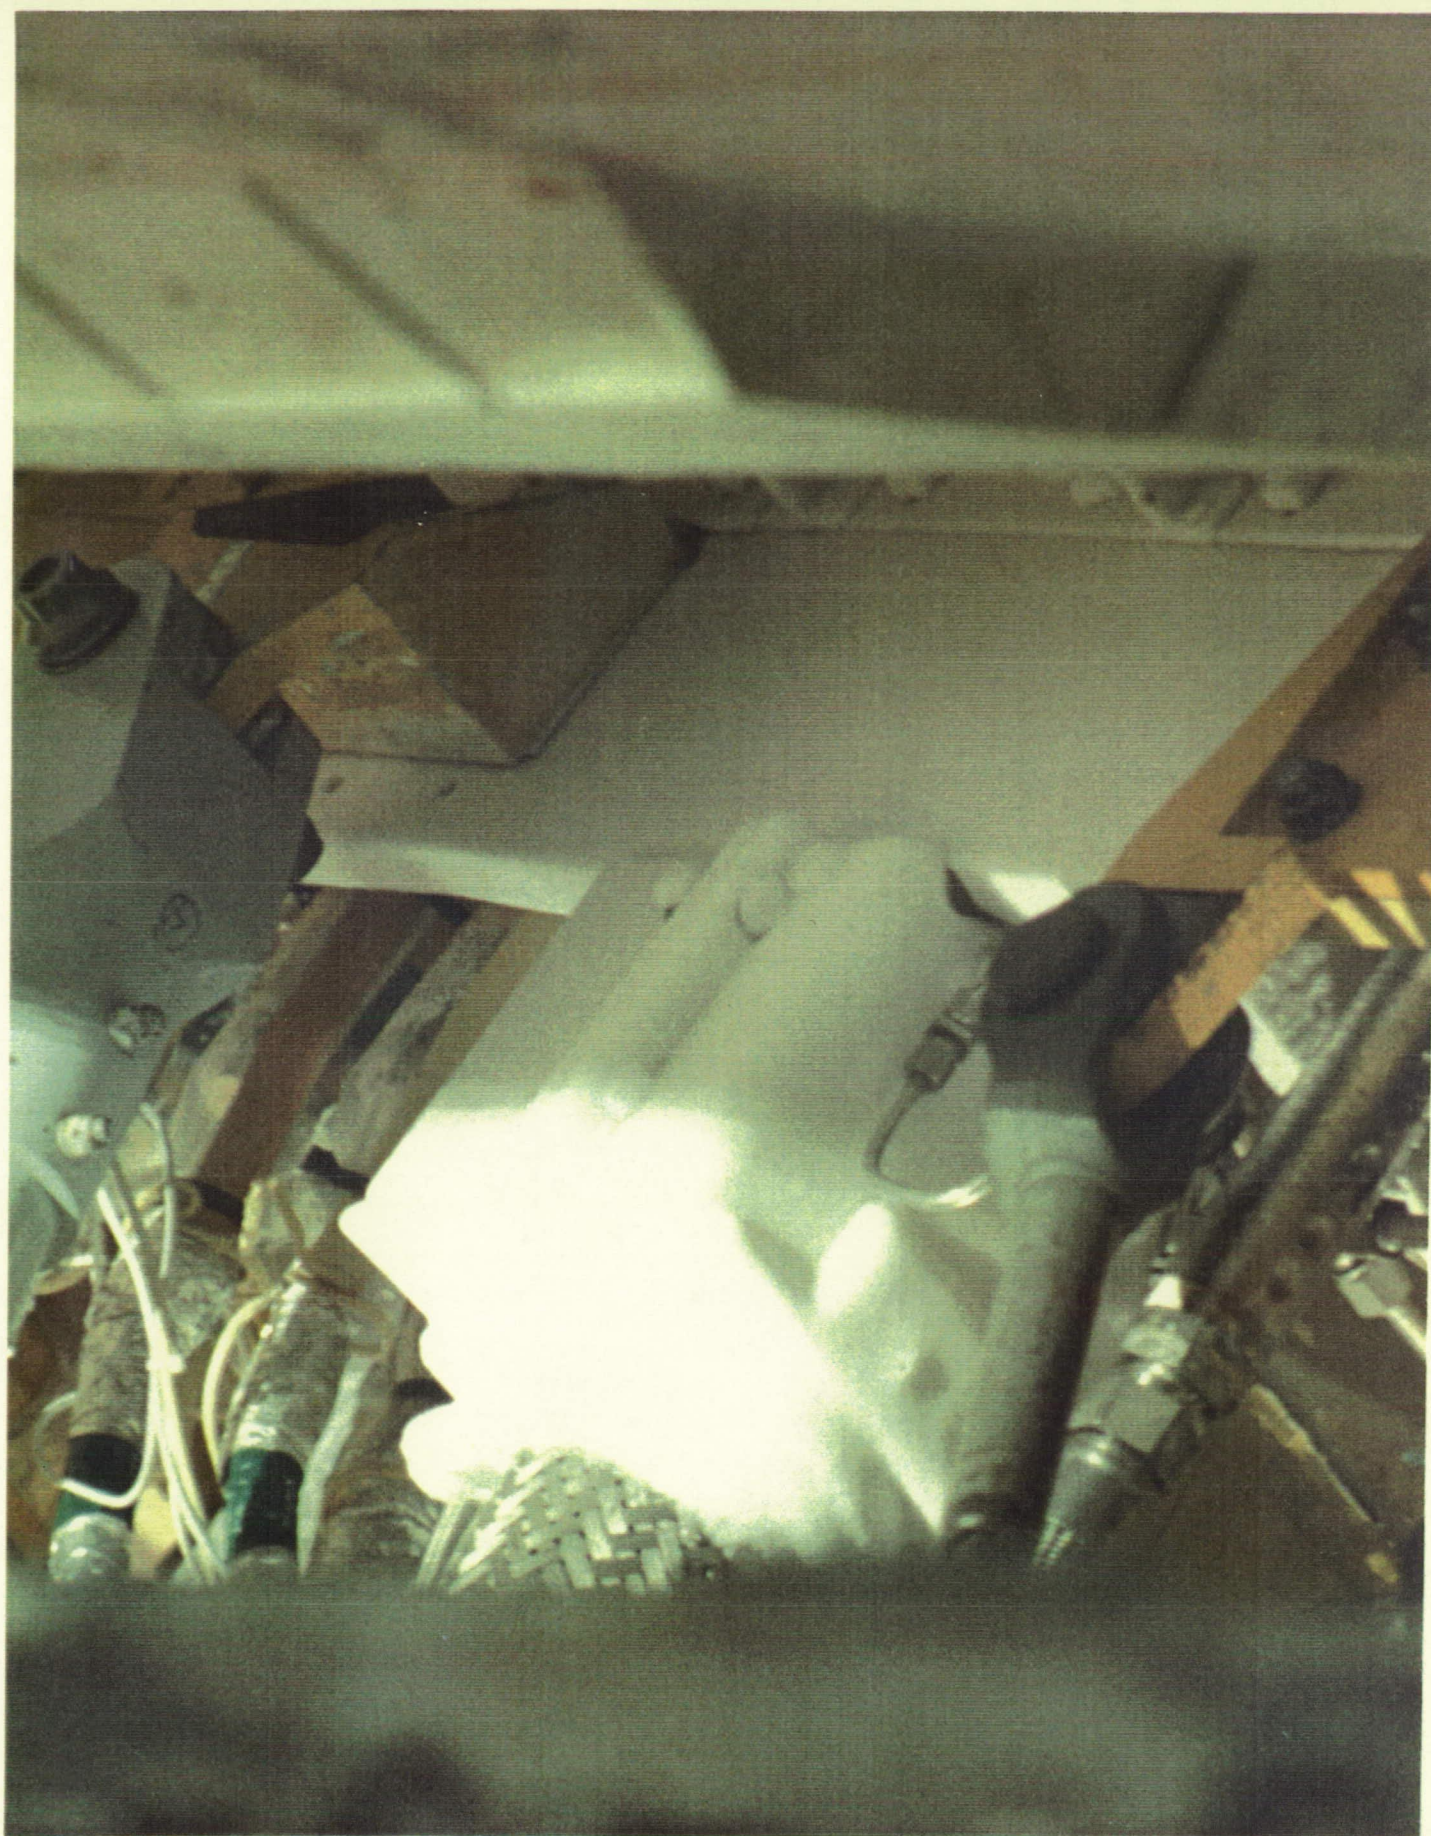
Ice/frost typically covers the 1-1/2 inch high point bleed QD
purge shroud
